Thermal Imaging Services

Thermographic Report March 2011

MCC Location: MCC26-244	Mill Area: Frontside
Equipment No: 03210-190-07502	Severity: Severe
Description: Primary Screen Number 2

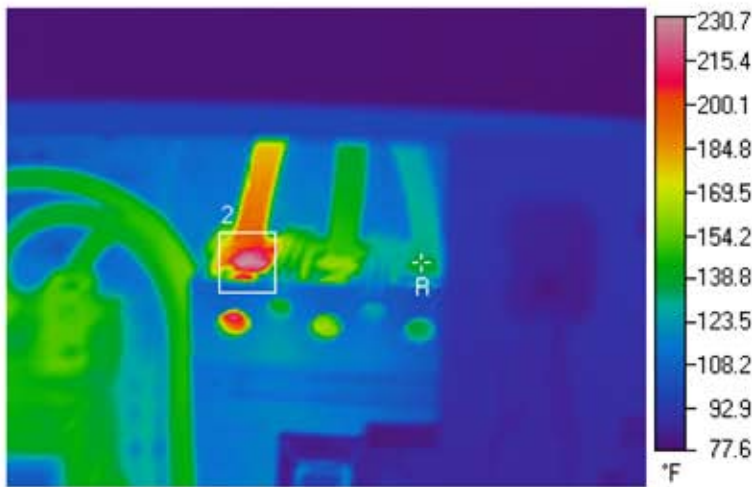
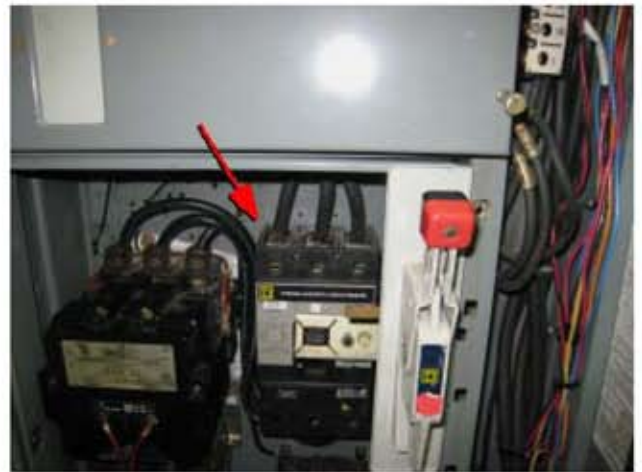
Ref.	Rect2
Emiss.	0.95	0.95
Avg		180.6 °F
Min		111.5 °F
Max	141.5 °F	238.2 °F
Delta		96.7 °F

Problem	Poor connection left phase line side breaker. T>200F
Recommended remedial action	Clean wire, inspect for damage, re-torque
Inspector	Thomas "Jeff" Motes, Jr., PE
Corrective action taken	
Repaired by
